SCHEDULE OF CONDITION

**Warehouse
XXX
XXX Erith,
Kent. DA8 XXX**

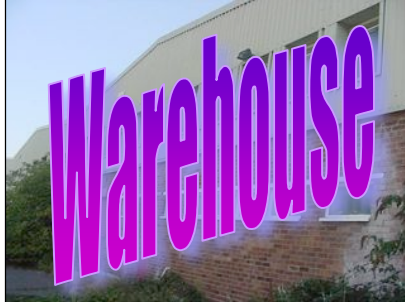
FRONT ELEVATION
(- Roadside)

DESCRIPTION	CONDITION	ACTION REQUIRED
<p>Roofs:</p> <p>Not visible.</p>		<p>We recommend that the roof is viewed via a cherry picker access or is excluded from the lease.</p>

<p>Parapet walls: Leaking Right hand parapet wall Metal coping stone on brickwork parapet wall.</p> <p>Left hand parapet wall No coping stone Brickwork with lead flashing</p>	<p>Brickwork is weathered and lead flashing we believe is leaking.</p>

<p>Deteriorating pointing.</p>   <p>Leaks into the property. Brickwork weathered. Both go to valley gutters which are leaking into the property.</p>	<p>Re-point and check the flashing.</p> <p>Re-point, check flashing and add a metal coping stone.</p>
<p>Gutters and Downpipes:</p> <p>Internal</p> <p>Soil and vent pipes:</p>	<p>Leaking.</p>   <p>Drainpipes disconnected and damaged.</p>  	<p>Ensure all gutters are watertight and falling towards the downpipe. Repair and secure as necessary, ensure downpipes are clear.</p> <p>Repair.</p>

<p>Walls: Metal Frame: Metal Structural frame</p> <p>Cladding: First floor level: Profile metal sheeting</p> <p>Ground floor level: Stretcher bond</p> <p>Cracks:</p> <p>Concrete Lintels:</p>	<p>Water has been entering the property via the valley gutters and there have also been amendments internally and the floor is subsiding.</p> <p>Some areas where metal sheeting is visible behind the protective coating. Other areas where the fixing bolts are rusting.</p> <p>Marked particularly by overflow water discharge</p> <p>Joints to brickwork opening up on right hand side have been weathered.</p> <p>There is extensive cracking to the front elevation. Vertical stepped cracking indicating the property is dropping away to the road.</p>

<p>Vegetation covering the base of the property. In some areas we can see a grey painted concrete foundation.</p>	<p>Exclude the metal frame structure from the lease. We also noted that it was starting to rust and had no fire protection.</p> <p>Repair</p> <p>All the overflows need extending, we can see six that have been cut back into the wall.</p> <p>Exclude from the lease.</p>

<p>Windows:</p> <p>High level: Eight windows, six small, two large. Metal, single glazed</p> <p>It should be noted that next door has all their windows with security grills assumed due to theft and vandalism in the area.</p> <p>Lower level: Three single, two double high level window and one low level window with roller shutter over it. High level windows have bars behind them.</p> <p>Two large windows with roller shutters one was up and one was down at the time of our survey.</p> <p>Central entrance door: Timber painted, grilled</p>		<p>Ease and adjust. Use a rust stop agent and redecorate.</p> <p>Use a rust stop agent and redecorate.</p> <p>Ease and adjust. Use a rust stop agent and redecorate.</p>
--	--	--

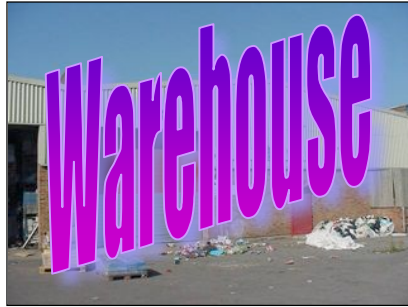
REAR ELEVATION

DESCRIPTION	CONDITION	ACTION REQUIRED
Roofs: Not visible.		We recommend that the roof is viewed via a cherry picker access or is excluded from the lease.
Parapet walls: Valley gutter:	Valley gutter to the base of the parapet walls is also leaking.	As front elevation
Gutters and Downpipes:		As front elevation

<p>Walls: Metal Frame: Metal Structural frame</p> <p>Cladding: First floor level: Profile metal sheeting</p> <p>Ground floor level: Stretcher bond</p> <p>Cracking: Brickwork section with boarding concealing a tank to the left hand side (all directions given as you face the property)</p>	<p>Some has been displaced, some has impact damage and some is missing particularly around the vehicle access door.</p> <p>Old fixing holes that have not been blocked and the coating is starting to deteriorate.</p> <p>Various areas of cement repairs to the brickwork, all of them are untidy and messy. There are also marks and staining to the wall, mortar and paint.</p> <p>Horizontal stepped cracking to the front wall caused by the dropping of the floor that can be seen within.</p> <p>Boarding deteriorating (vertical cladding). Covered with vegetation.</p>	<p>Repair, prepare and redecorate.</p> <p>Replace boarding. Remove vegetation.</p>

<p>External detailing:</p> <p>Roller shutter door to one and a half storey high; Top half painted, bottom half not painted.</p> <p>Entrance door:</p> <p>Two grills</p>	<p>Needs redecoration has damage to the top</p>

<p>Damaged shutter box</p>	<p>Repair, prepare and redecorate.</p> <p>Repair, prepare and redecorate.</p>

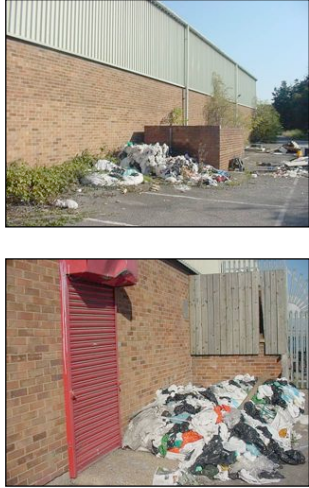
<u>OUTSIDE AREAS</u>		
DESCRIPTION	CONDITION	ACTION REQUIRED
<p>Fly tipping</p>

<p>There is extensive fly tipping both to the front of the property and around the property. There are fly tipping notices with fines from £20,000 - £50,000.</p>	
<p>Tarmac area to front Marked out with parking bays Drop towards the road Several manholes noted none lifted.</p>	<p>Overgrown</p>	<p>Clear vegetation</p>

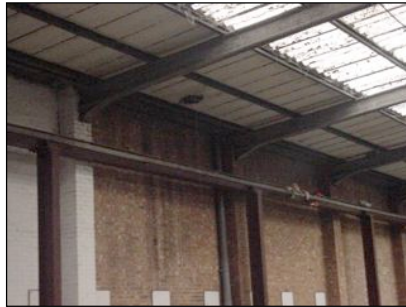
Warehouse

DESCRIPTION	CONDITION	ACTION REQUIRED
<p>Ceilings:</p> <p>Metal portal frame exposed at roof level</p> <p>Roofing material believed to be corrugated asbestos sheets</p> <p>Ceiling has been underclad with asbestos visible</p>	<p>Believed to be asbestos</p> <p>Water leaking to:- front side valley gutters</p> <p>Underclad sheeting showing signs of deterioration to the joints indicating dampness is coming through.</p>

<p>Only small areas are visible. Needs asbestos survey, specialist check. Please note we are not asbestos surveyors.</p>

<p>Walls: Metal Frame: Metal frame: Upright frame is concealed brickwork piers. Nine metal frames visible. Partly painted partly not.</p> <p>Front gable 1st floor level: Painted red brickwork Two window openings placed in it, uncut brick with two plastic windows.</p> <p>Rear gable over-cladding panels</p> <p>Right hand side wall Left hand side wall</p> <p>Up stand to either side of warehouse walls approximately 300mm in concrete possibly added to take the lifting device.</p>	<p>Rusting visible to metal frames.</p>

<p>Cracking to much of the brickwork piers encasing the frame</p> <p>Various marks including painted areas and old fixing points that have not been filled.</p> <p>Deterioration visible to valley gutters on both sides</p> <p>Deteriorating and dirty. Outside light visible.</p>	<p>Repair, prepare and redecorate.</p> <p>Make good</p> <p>Clean and make good</p>
---	--	--

<p>Internal Downpipe Plastic</p>	<p>Some leaking heavily and past repairs can be seen.</p>

<p>Make watertight</p>
<p>Floors: Concrete Partly painted</p> <p>To rear where roller shutter door is located</p>	<p>Subsidence.</p> <p>Floor dropped 50-75mm on average but ranging up to 150mm</p>	<p>Exclude from lease.</p>
<p>Detailing: Windows: Internal windows only Two plastic windows</p> <p>Doors: Roller shutter door Pedestrian/fire exit door Door into office area</p>	<p>Cut into the wall in an amateur style. Not made good.</p>	<p>Repair, prepare and redecorate.</p>
<p>Lifting device 3.2 tonne Demag</p>	<p>Used to run from front to back but has been amended to take in the front two bays only</p>	<p>Exclude from lease</p>
<p>Services: Not working at the time of our survey.</p>

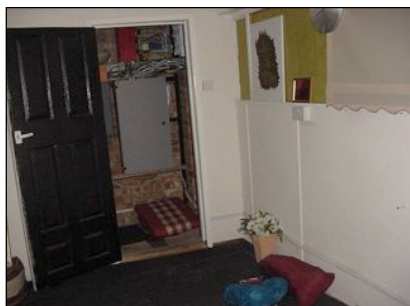
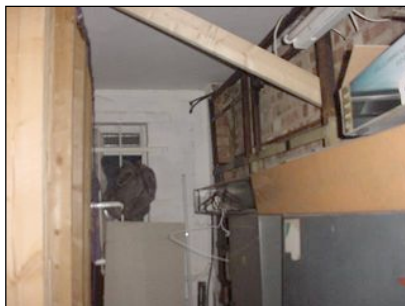
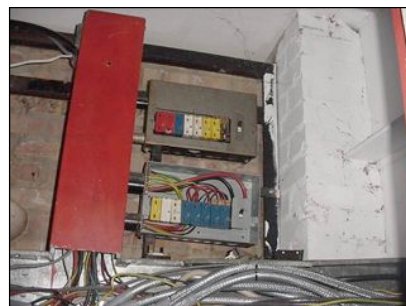
Work Area - front left hand side
Service Cupboard - far left hand end

DESCRIPTION	CONDITION	ACTION REQUIRED
Ceilings: Painted	Marked	Repair, prepare and redecorate.
Walls: Painted	Marked	Repair, prepare and redecorate.
Floors: Hippo carpet over concrete floor	Marked	Replace
Detailing: Windows: Metal and single glazed Door: Timber	Marked	Ease and adjust. Use a rust stop agent and redecorate. Repair, prepare and redecorate.
Services: Not working at the time of our survey.

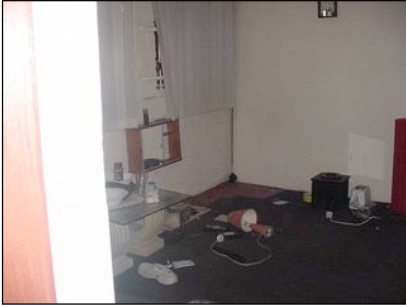
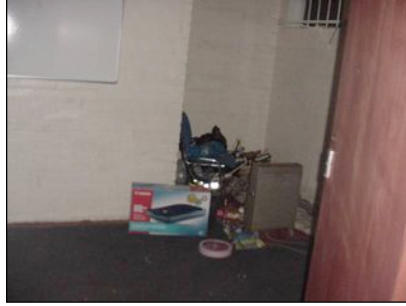
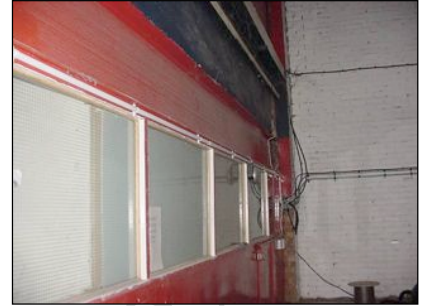
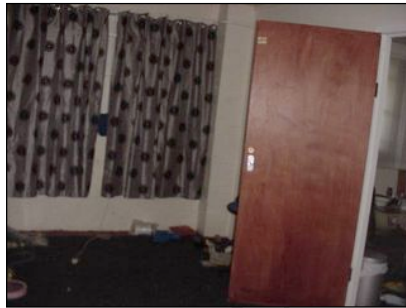
Walk through office – front left hand side

DESCRIPTION	CONDITION	ACTION REQUIRED
Ceilings: Painted	Marked	Repair, prepare and redecorate.
Walls: Painted plaster Painted brickwork	Marked	Repair, prepare and redecorate.
Floors: Painted concrete floor	Marked	Exclude from the lease

<p>Detailing: Windows: Metal and single glazed Door: Timber</p>	<p>Marked</p>	<p>Ease and adjust. Use a rust stop agent and redecorate. Repair, prepare and redecorate.</p>
<p>Services: Not working at the time of our survey.</p>

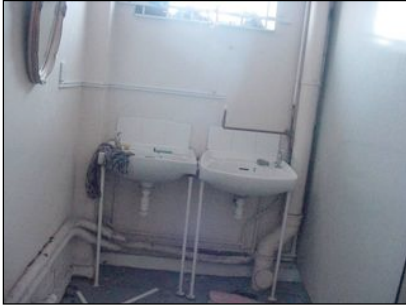
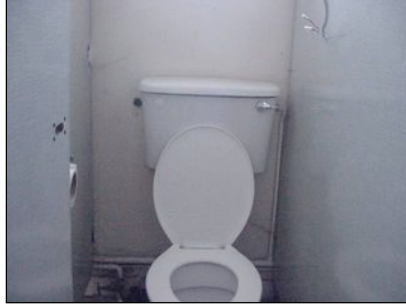
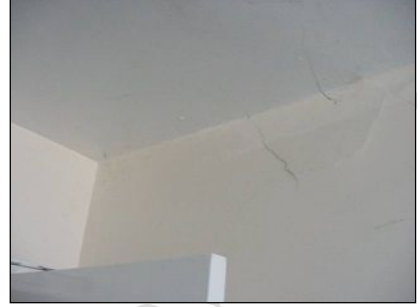
Ladies' Toilets - far front right hand side

DESCRIPTION	CONDITION	ACTION REQUIRED
Ceilings: Painted	Marked	Repair, prepare and redecorate.
Walls: Painted Partitions: Formica	Marked Signs of cracking and structural movement Dampness.	Repair, prepare and redecorate.

<p>Floors: PVC tile on to concrete floor.</p>	<p>Subsiding. Dropping towards front of the property.</p>

<p>Exclude from lease</p>
<p>Sanitary Ware: Two WC's and wash hand basin</p>		<p>Deep clean</p>
<p>Soil and vent pipe: Internal</p>		
<p>Joinery: Windows: Metal Doors: Flush painted</p>	<p>Marked</p>	<p>Ease and adjust. Use a rust stop agent and redecorate. Repair, prepare and redecorate.</p>
<p>Services: Not working at the time of our survey.</p>

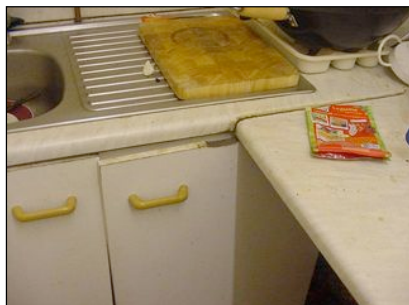
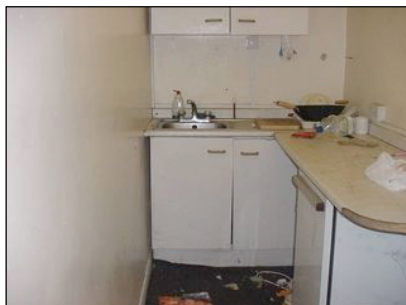
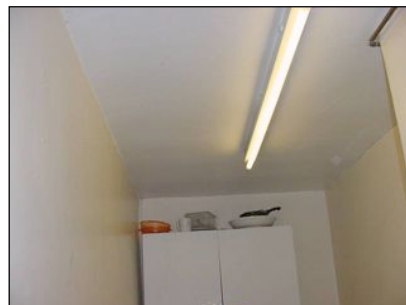
Kitchenette
(Internal galley kitchen)

DESCRIPTION	CONDITION	ACTION REQUIRED
Ceilings: Painted	Marked	Repair, prepare and redecorate.
Walls: Painted	Heavily marked.	Repair, prepare and redecorate.
Floors: Hippo carpet onto concrete floor	Marked	Replace
Detailing: Doors: Flush painted	Marked	Repair, prepare and redecorate.
Kitchen Equipment: The kitchen equipment is domestic quality and has not been inspected.	Dirty and marked	Replace.
Services: Not working at the time of our survey.

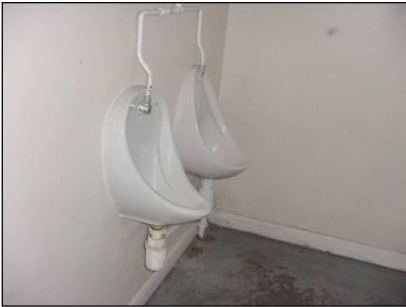
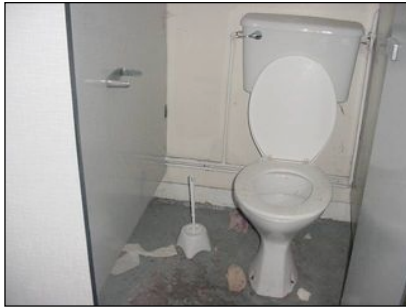
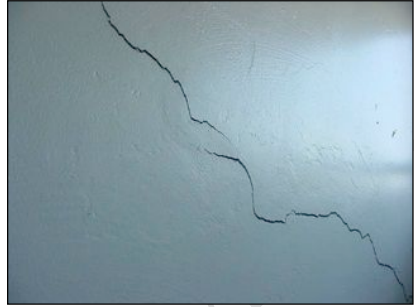
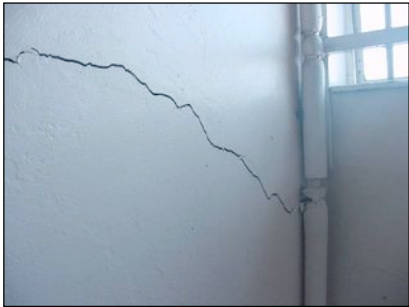
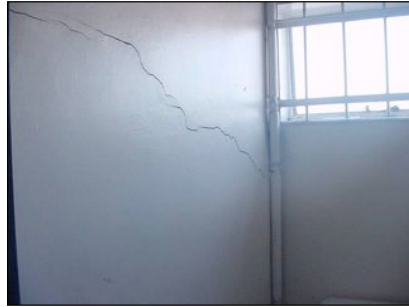
Gentlemen's Toilets

DESCRIPTION	CONDITION	ACTION REQUIRED
Ceilings: Painted	Marked	Repair, prepare and redecorate.

<p>Walls: Painted</p> <p>Dividing wall between ladies and gents toilets</p> <p>Cracking:</p> <p>Skirtings:</p> <p>Partitions: Formica</p>	<p>Marked and cracked</p> <p>Heavily cracked we believe due to subsidence.</p> <p>Coming away</p>

<p>Repair, prepare and redecorate.</p> <p>Exclude from the lease</p>
<p>Floors: Painted concrete floor</p>	<p>Marked, showing signs of dropping towards the front of the property.</p>

<p>Subsidence exclude from the lease</p>
<p>Sanitary Ware Two WC's, two urinals and two wash hand basin</p>		<p>Deep clean</p>
<p>Joinery: Windows: Metal</p> <p>Doors: Flush painted</p>	<p>Dated</p> <p>Marked</p>	<p>Ease and adjust. Use a rust stop agent and redecorate.</p> <p>Repair, prepare and redecorate.</p>
<p>Services: No services working at the time of our survey.</p>

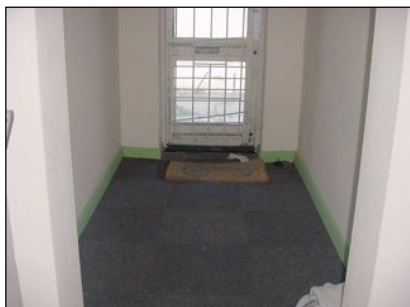
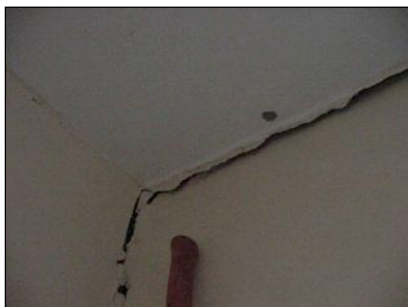
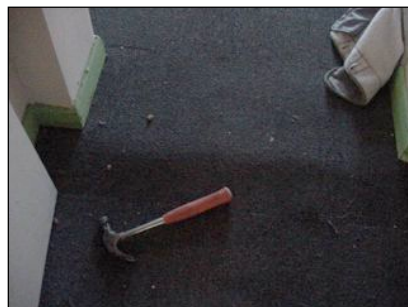
Lobby/entrance to stairs

DESCRIPTION	CONDITION	ACTION REQUIRED
Ceilings: Painted	Marked. Cracked.	Repair, prepare and redecorate.
Walls: Painted Skirtings: Painted green	Marked Racking cracking that has been repaired. Significant cracking between walls and ceiling.	Repair, prepare and redecorate
Floors: Hippo carpet onto concrete floor	Drop in floor level partly hidden by carpet.	Drop may relate to subsidence. Exclude from the lease.

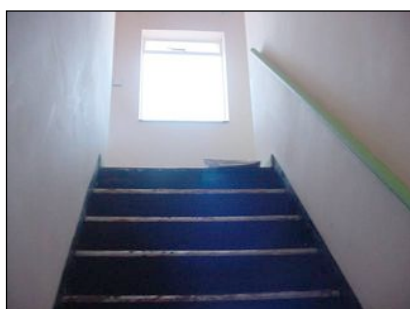
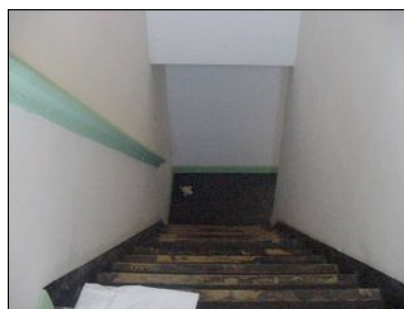
Stairs

DESCRIPTION	CONDITION	ACTION REQUIRED
Ceilings: Rectangular suspended ceiling tile system. Painted over Light hanging down Architraves	Marked Damaged around the entrance door to the left hand side.	Repair, prepare and redecorate.
Walls: Painted	Painting hiding blown plaster and cracking. Lost their key. Vertical crack approximately two metres in length.	Repair, prepare and redecorate.
Stairs: Concrete, nosings have been removed as once carpeted.		
Landing Window: Small metal	Noted some of window glazing putty had come out.	Ease and adjust. Use a rust stop agent and redecorate. May need to be re-glazed.
Services: No services working at the time of our survey.

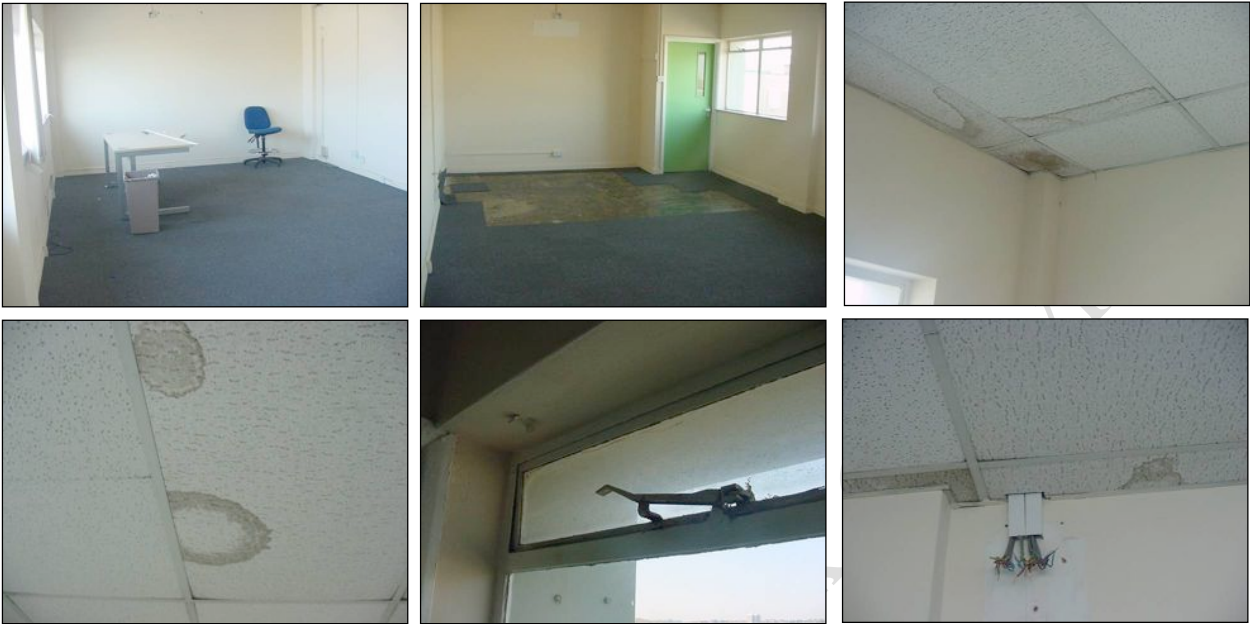
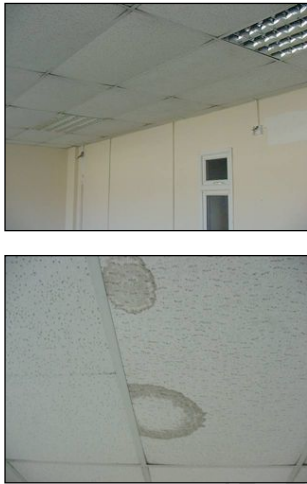
Left hand Office

<p>Ceilings:</p> <p>Rectangular suspended ceiling tile system.</p> <p>Inset lights</p>	<p>Signs of water staining. Tiles are cupping indicating dampness is coming through the roof.</p>

<p>Make watertight. Replace ceiling tiles.</p>
<p>Walls:</p> <p>Painted</p>	<p>Marked areas and signs where high level heating areas have been removed.</p>	<p>Repair, prepare and redecorate.</p>
<p>Floors:</p> <p>Carpet tiles over a polyvinyl tile</p>	<p>May have an asbestos content</p>	<p>Replace</p>
<p>Detailing:</p> <p>Windows: Three large metal windows.</p> <p>Door: Painted green with vision panel Georgian wire polished glass</p>	<p>Marked</p>	<p>Ease and adjust. Use a rust stop agent and redecorate.</p> <p>Repair, prepare and redecorate.</p>
<p>Services:</p> <p>The cabling has been removed with the exception of the socket points.</p>

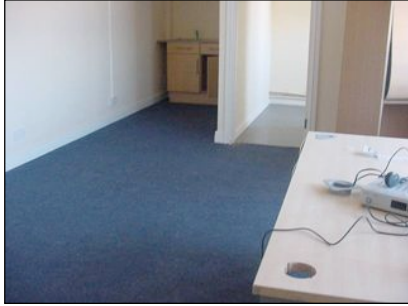
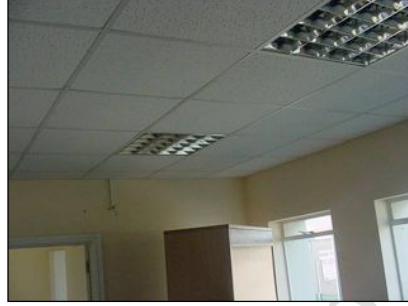
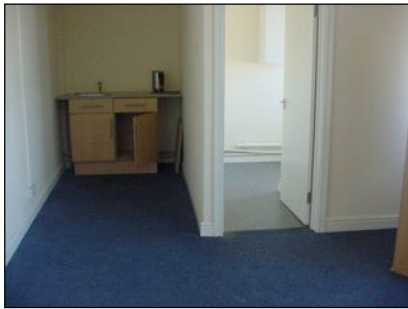
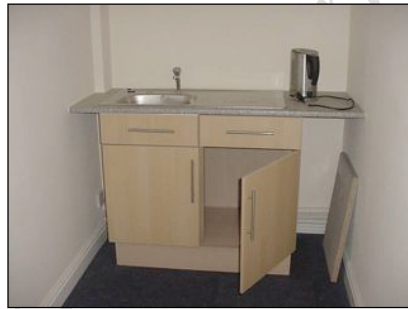
Right Office
with kitchenette area, wash hand basin and sink

DESCRIPTION	CONDITION	ACTION REQUIRED
<p>Ceilings:</p> <p>Square suspended ceiling tile system.</p> <p>Has an old ceiling above it.</p> <p>Inset lights</p>	<p>Dated</p>	
<p>Walls:</p> <p>Painted</p>	<p>Average. Some marks around the internal window</p>	<p>Repair, prepare and redecorate.</p>
<p>Floors:</p> <p>Carpet tiles over a polyvinyl tile</p>	<p>May have an asbestos content</p>	<p>Replace</p>

<p>Detailing: Windows: Three crittall metal windows. Door: Timber</p>	<p>Top glass pane broken. Marked</p>	<p>Ease and adjust. Use a rust stop agent and redecorate. Repair, prepare and redecorate.</p>
<p>Services: No services working at the time of our survey.</p>

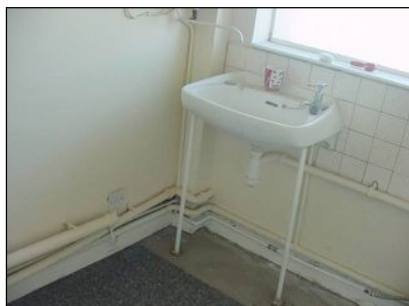
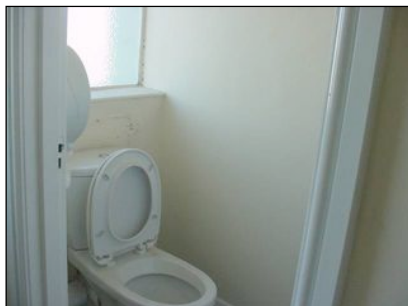
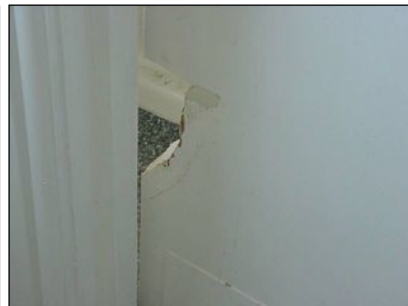
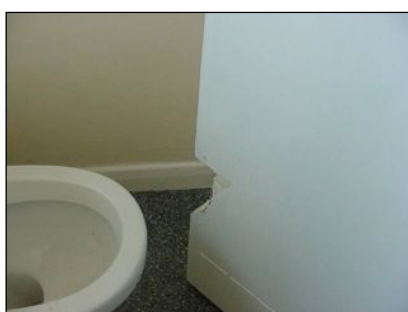
Toilet
within right hand office

DESCRIPTION	CONDITION	ACTION REQUIRED
Ceilings: Suspended ceiling tile system Painted over	Dated	Replace
Walls: Painted some tiles around the wash hand basin	Signs of water damage around wash hand basin.	Repair, prepare and redecorate.
Floors: Vinyl	Cut short around sink area.	Replace

<p>Sanitary ware: WC and wash hand basin Some tiles around wash hand basin</p>	<p>Ingrained dirt. Tiles have been removed around the WC</p>	<p>WC needs to be repositioned so that it does not hit the door. Deep clean Make good</p>
<p>Detailing: Windows: One metal Door into WC</p>	<p>Cracking and blown plaster around some of the windows. Cut door so you can open it as toilet is too close to it!</p>	<p>Ease and adjust. Use a rust stop agent and redecorate. Repair, prepare and redecorate.</p>
