# COMMERCIAL BUILDING SURVEY

## Large Warehouse

**INDEPENDENT CHARTERED SURVEYORS**

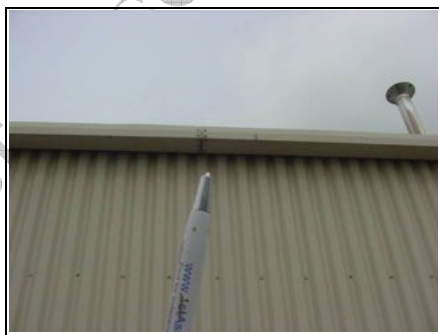
We noted that the gutters did not appear to be working, as we could see vegetation growing from them and also we could see leaks at the joints.

Leaking gutter

**ACTION REQUIRED:** We would always recommend that the gutters and downpipes are cleaned out, the joints are checked and the alignment checked to ensure that the gutters fall towards the downpipes.

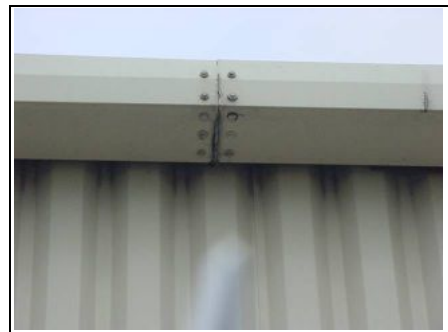
Close up

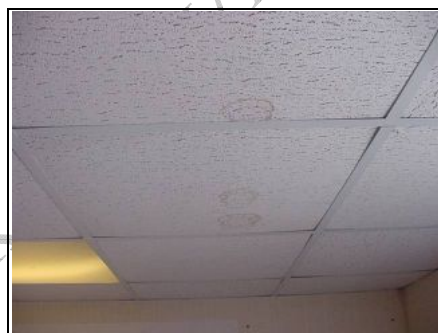
We can see staining to the ceiling tiles. We believe this to relate to condensation as opposed to roof leaks (although we have not accessed the roof) and we can see this to the perimeter. In our experience a warm office during cold winter days can result in condensation to the underside of the roof.

Staining to ceiling

**ACTION REQUIRED:** A very difficult problem to solve completely in this era of property. We would recommend adding insulation and air conditioning units (cooling and heating units).

**ANTICIPATED COST:** In the region of £5,000 to £10,000, depending upon the amount of air conditioning units / air heating / air cooling units you have. Please obtain quotations.

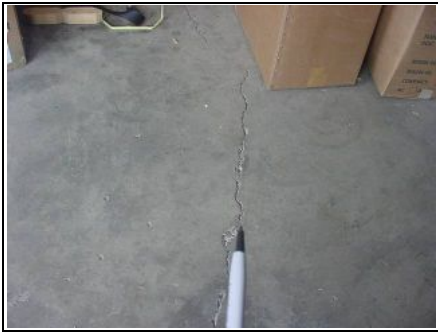
We noted cracking to the floor (not to be confused with construction joints). This is covered to some extent by the carpets. This, combined with the dampness, means that the floor may be blistered and there may be hollow areas beneath it. Depending upon the weight that you are putting on the floor this may or may not be of importance.

Cracked joints

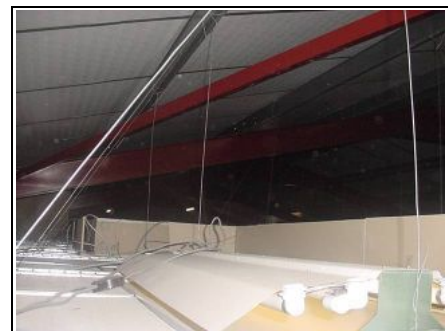
We noted there was no separating fire stop or compartmentisation between the office areas and the storage areas. Depending upon what configuration you will have with the building we believe it is essential to have fire breaks added.

Shows the partitions raised above the suspended ceiling but not to the roof to form a fire break

**ACTION REQUIRED:** Seal the existing fire wall / fire barrier properly and add in proper fire stops around the fire exit stair cases, as they did not look to meet the current half hour / one hour fire protection around escape routes.

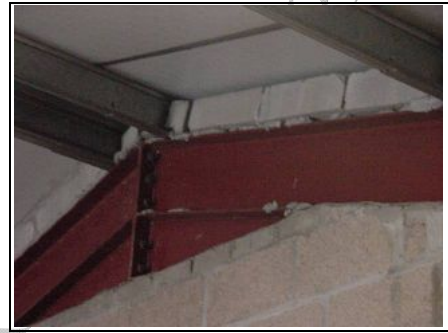
Messy division wall between stock room area and racking area

Close up

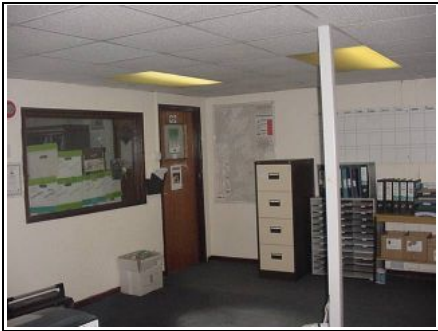
The standard of lighting within the office is not to current standards, where it is normally recommended Category 2 lighting or equivalent, depending upon what is being carried on in the office.

Office lights

**ACTION REQUIRED:** Upgrade to Category 2 lights. There are many factors when upgrading that have to be take into consideration.

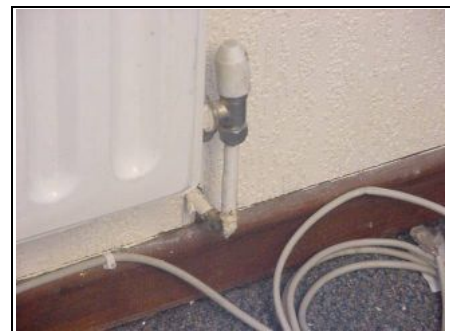
The heating system used microbore pipes, which are smaller pipes than usual. We find that these tend to not work as efficiently, simply because the water cannot get round the smaller bore and then tends to block.

Microbore pipes

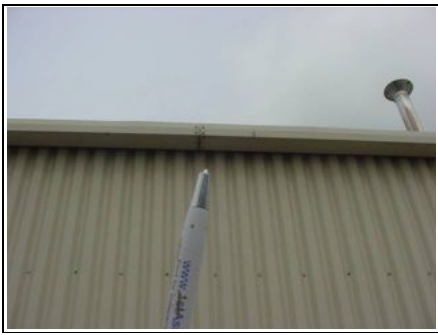
The property has profile metal gutters and plastic downpipes. Please see our comments in the Executive Summary regarding the leaking gutters. We also noted areas of vegetation growing out of them indicating they have not been cleaned for some time and this will in turn cause leaks.

Leaking gutter right hand side

**ACTION REQUIRED:** Please see our comments in the Executive Summary.

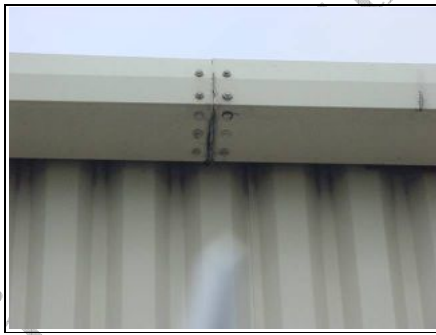
Close up of leaking gutter

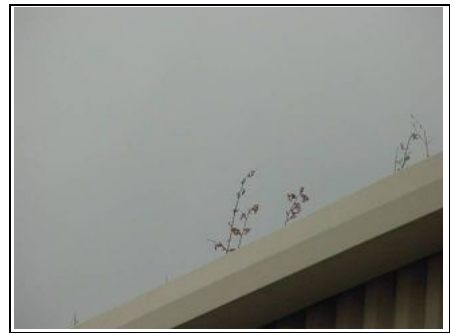
Vegetation growing out of gutter

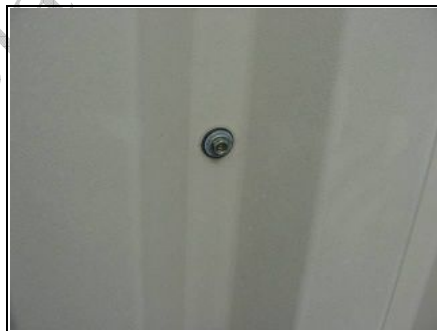
Missing end cap

**ACTION REQUIRED:** It is well worth sending someone round with a pack of end caps to fit on to the bolts that fix the cladding in, as these will ultimately rust away.

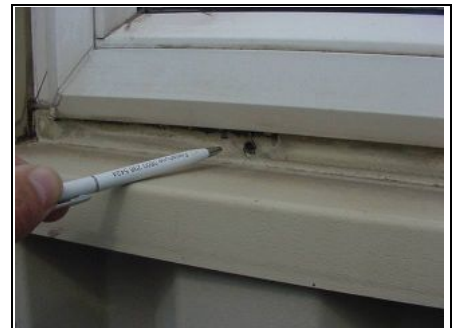
Fixing bolts missing altogether  
need to be replaced

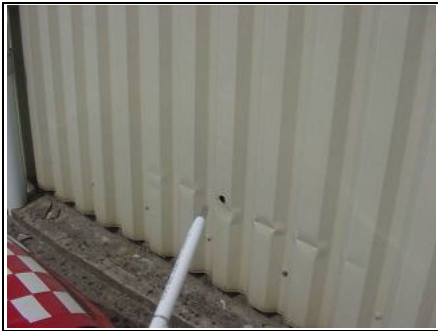
Impact damage caused by cars

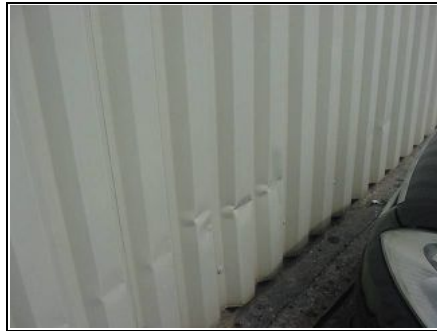
Low level impact damage – very difficult to repair and much better to put a barrier up to stop the cars running into it.

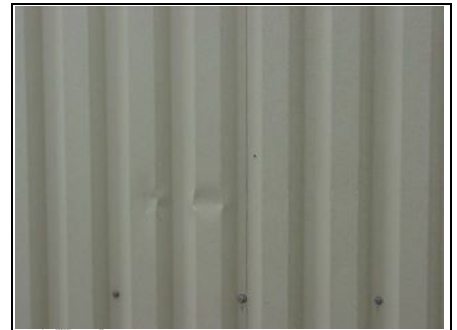
Minor impact damage

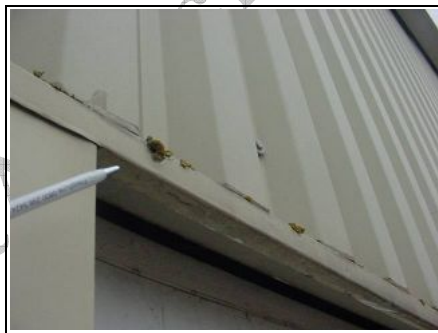
There are some areas where ledges have been formed and areas where water can be held

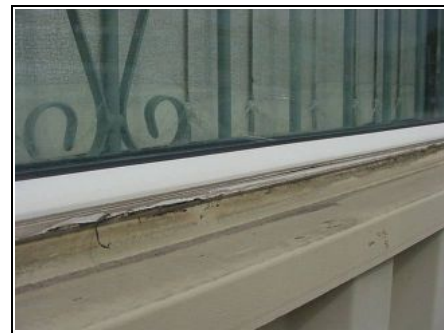
Mastic seals going around the windows would benefit from being repaired.

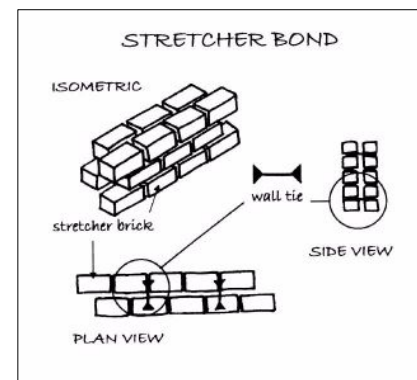
There is minor efflorescence which indicates the brickwork is getting wet and not drying.

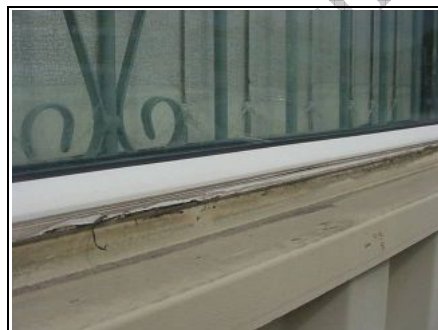
The property has plastic double glazed windows, which look to be below average quality. The seals around them have deteriorated. Failure of the seal leads to condensation between the two panes of glass and simply replacing the affected units may not provide a satisfactory long-term solution.

Plastic windows close up.  
Plastic sill needs re-sealing

**ACTION REQUIRED:** Re-seal.

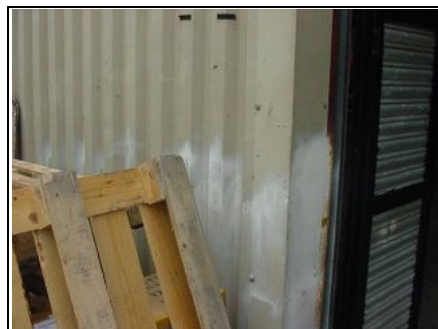
We have not seen the roller shutter door in action. There was some impact damage around it.

Paint around roller shutter door

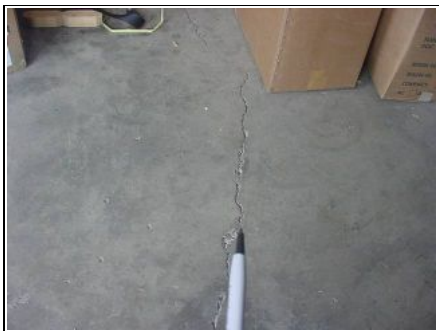
Pen indicates hairline cracking

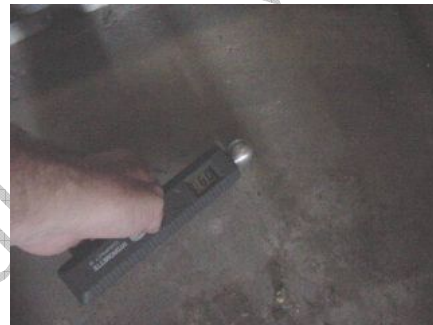
The ground floor is solid under foot so we have assumed is concrete. There is damp on the left hand side in the fire exit area.

High damp meter readings were gained in the fire exit area on left hand side

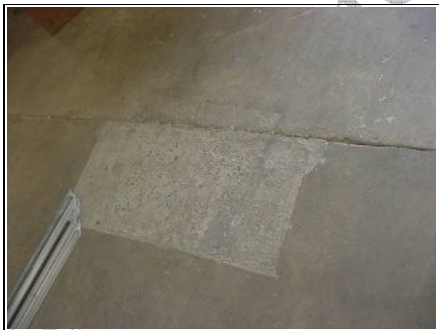
Damage to floor

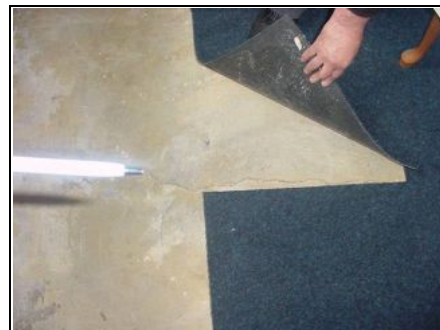
Show room floor damaged

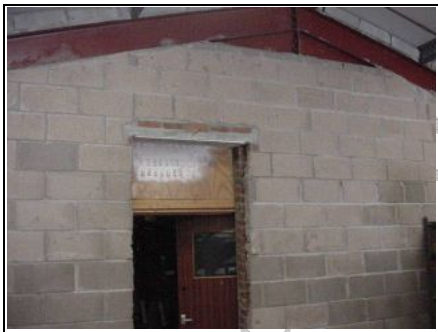
Fire break without the fire door!

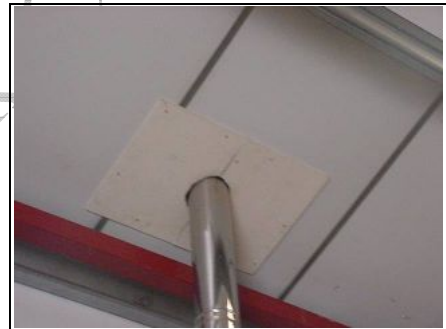
In this age of property there is a danger that the roof has been under and over clad and is hiding the asbestos within. This can be very costly if this is not identified.

Possible asbestos where flue goes through roof

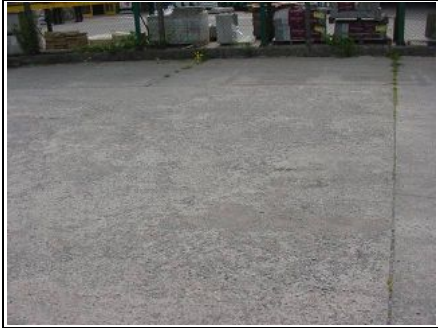
We noted that the car park is spalling and the fence is rusting and would benefit from redecoration.

View of car park with a spalling surface

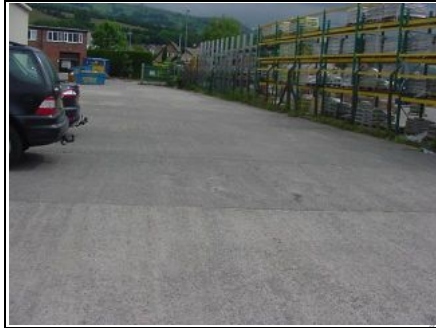
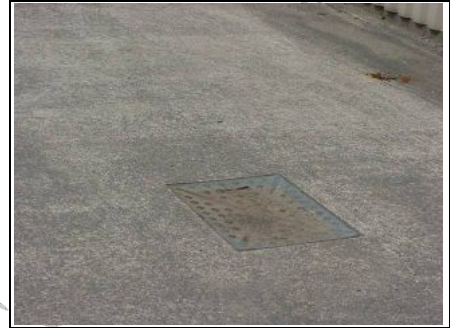
Lightweight manhole cover in car park and has dipped

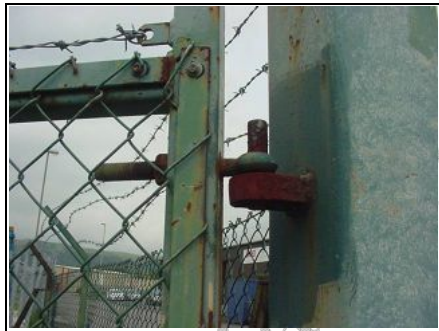
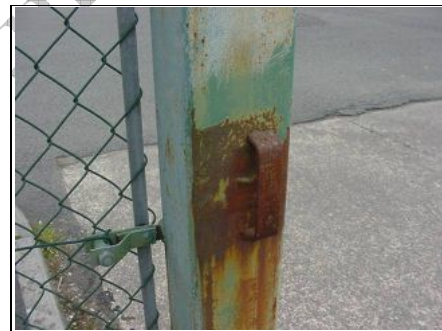
Rusting fence / entrance gate

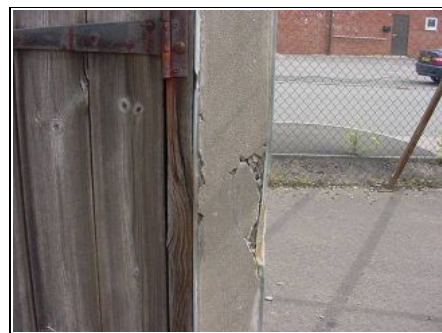
Render repairs to diesel shed
