# PROPERTY REPORT

**Warehouse**

**High Wycombe,  
Buckinghamshire. HP12 XXX**

We have been instructed to inspect and prepare a Report and Schedule of Condition for XXXX, High Wycombe, Bucks. HP12 XXX

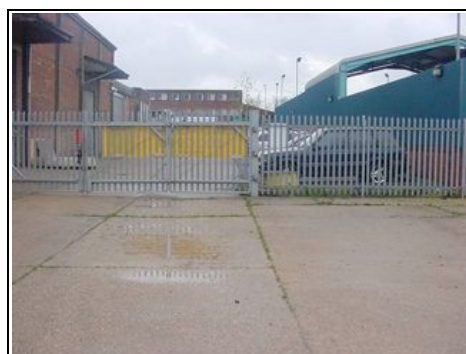
Shared access area within the boundary. Check a detailed plan to identify exactly where the boundary lines are.

Detailed drawings need to be provided with regard to the boundaries and shared access areas as well as associated responsibilities.

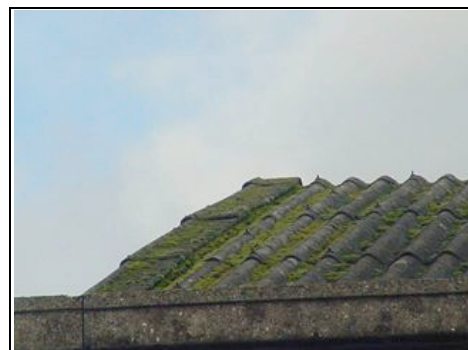
**1.0) Asbestos roof has moss sitting on it.**

The asbestos roof has moss sitting on it which means that the asbestos roof is starting to de-grade. An up to date asbestos report is required on the property as a whole and specifically to the roof and should be provide by the landlord or last tenant and should include tested asbestos samples. You need to familiarise yourself and be aware of the risks of asbestos in relation to your operation and the building as a whole.

Main roof moss covered

<b>% Assessment of Deterioration:</b>		<b>Landlord's Comments:</b>
<b>Moss coverage:</b>	30% at present	
<b>Surface Deterioration:</b>	30%

Please note we are not asbestos surveyors. You need to seek specialist advice with regard to this matter.

High level joint inspection recommended. Asbestos test required.

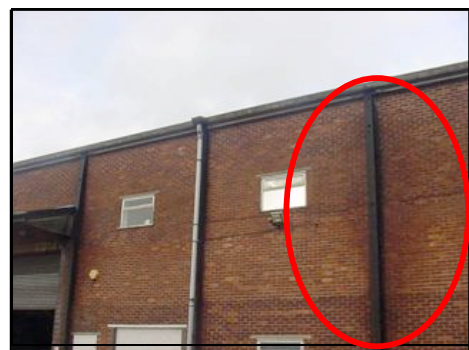
**2.0) Leaking concrete gutters**

You have a concrete gutter system that leaks. Whenever we come across this type of system it always tends to be leaking. This will cause damage and deterioration to anything stored within the unit and can and has caused deterioration to the brickwork in the form of spalling brickwork and cracks in the brickwork in one section.

Damp staining to brickwork from leaking gutters

<b>% Assessment of Deterioration:</b>		<b>Landlord's Comments:</b>
<b>Leaking:</b>	80% leaking

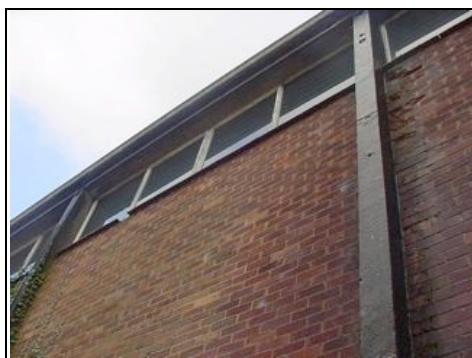
Water saturation  
Independent Chartered Surveyors

At the time of our inspection the brickwork was saturated as was the portal concrete frame. Long term saturation of these materials will cause defects. From our inspection it would appear that Bay 3 has been rebuilt previously in blockwork at high level and we could see that Bay 2 has movement to the brickwork around the pier and above the roller shutter door area. Bays 1 and 3 are also deteriorating and there is moss on Bays 5 and 6.

<b>% Assessment of Deterioration:</b>		<b>Landlord's Comments:</b>
<b>Spalling:</b>	Approx 5%	
<b>Areas saturated with rainwater from guttering and downpipes:</b>	60% - 70%	
	These areas will have accelerated deterioration

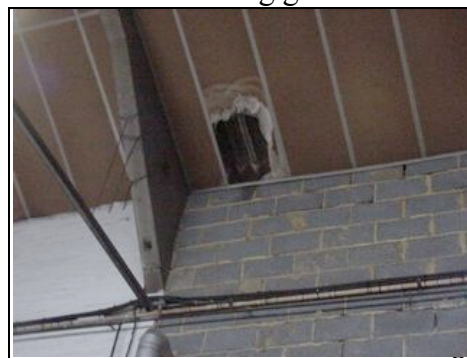
Blockwork at high level

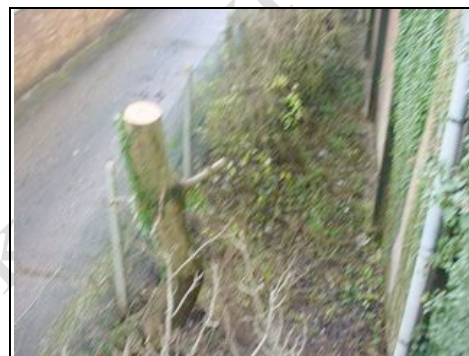
You advised us that you have been cutting back the trees to the rear of the property but there is still ivy growing up the face of the property to the rear on Bays 4, 5 and 6.

Cutting back of trees to rear

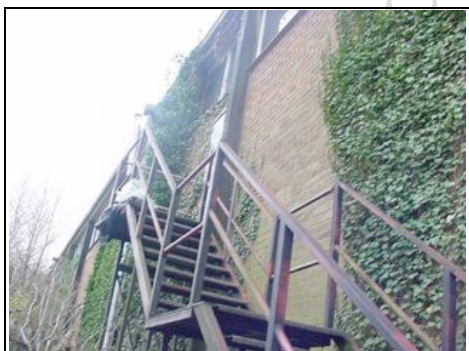
Ivy to rear

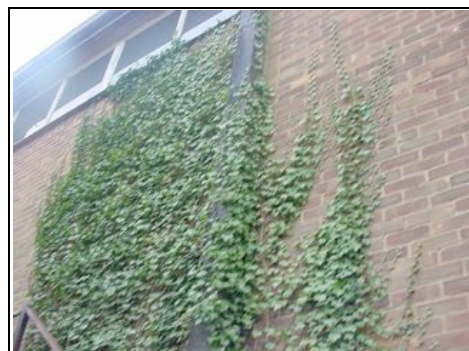
Close up of ivy

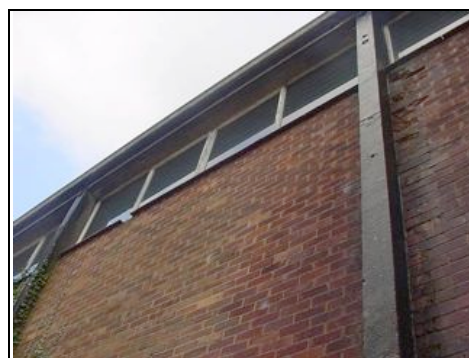
We also noted that the both the metal and timber windows have had little care and attention over the years. We would expect to find windows included in a Dilapidations claim requiring you to ease and adjust and repair, prepare and redecorate which will be very

High level windows

expensive. You will need to ensure that the condition of the windows is agreed, if anything the windows should be excluded from the lease.

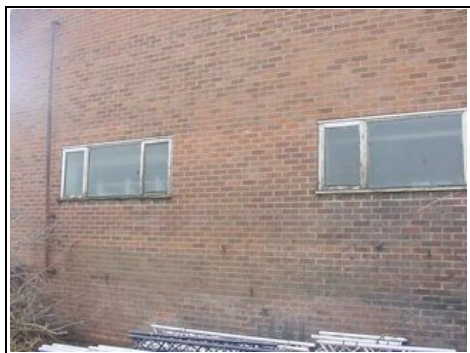
Windows deteriorating

<b>% Assessment of Deterioration:</b>		<b>Landlord's Comments:</b>
<b>Redecoration:</b>	100%	
<b>Repair and replacement of timber windows:</b>	100%

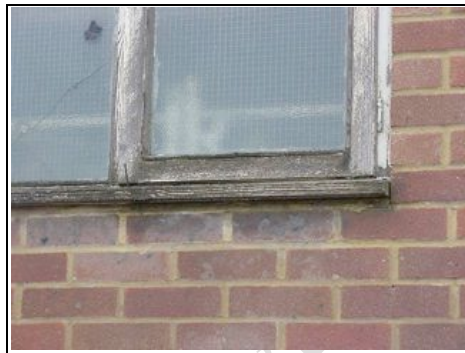
Close up of window in need of repair and redecoration

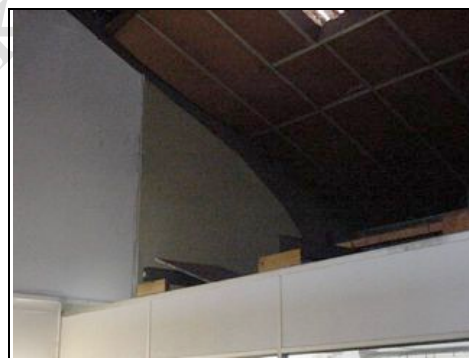
Most leases require an internal redecoration every four to five years and upon yielding up the lease (giving back the lease). As redecoration has not been carried out previously this makes it a more onerous liability to yourselves. You should seek appropriate compensation for this as it would fall under a typical Dilapidations claim.

Section not painted

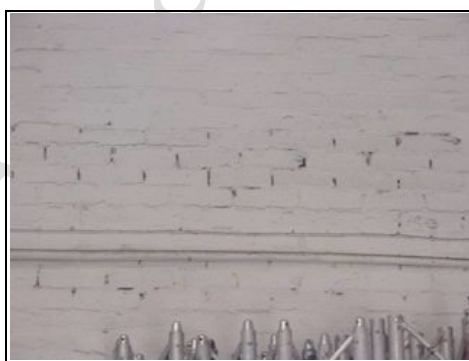
Re-pointing and redecoration required

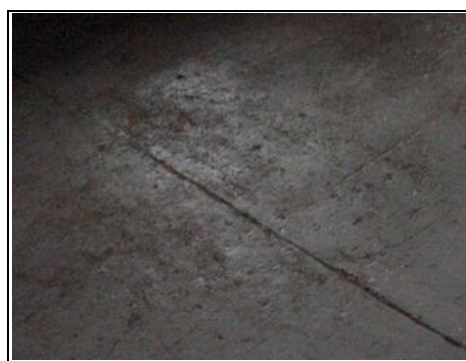
Floor with indents and marks

The floor has marks and indents.

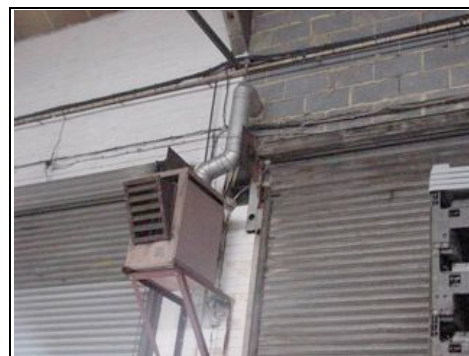
The heaters within the warehouse were not working at the time of our inspection. You need to be aware that most Dilapidations will require you to bring the heaters to working order even though, in our experience, very few people use these heaters.

ITT Reznor heater

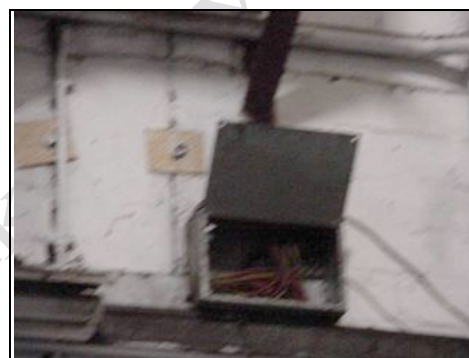
The electrics are dated.

Dated electrics

1. Electrics – An Institute of Electrical Engineers standards (IEE) test and report to be carried out by an NICEIC registered and approved electrical contractor or equivalent.
2. Space heating inspection and test report (you need to see these in working order)
3. Asbestos report with samples.
4. Note we have not checked that the roller shutter doors are working order and noted you were only using the roller shutter door to Bay 4 during the course of our inspection.
5. Drainage – closed circuit TV camera report.
6. Anything specific to this particular unit that you have discovered whilst occupying the property.
