# COMMERCIAL BUILDING SURVEY

## Large Warehouse

**INDEPENDENT CHARTERED SURVEYORS**

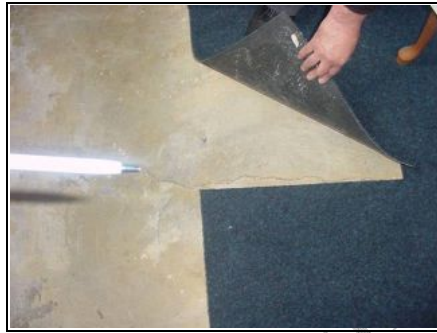
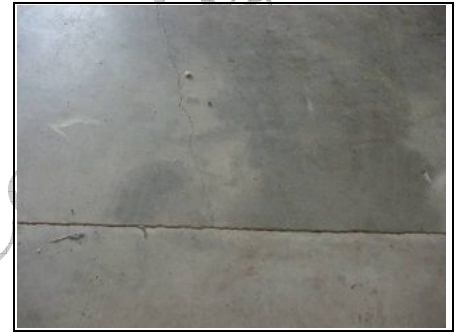
We noted cracking to the floor (not to be confused with construction joints). This is covered to some extent by the carpets. This, combined with the dampness, means that the floor may be blistered and there may be hollow areas beneath it. Depending upon the weight that you are putting on the floor this may or may not be of importance.

Construction joint

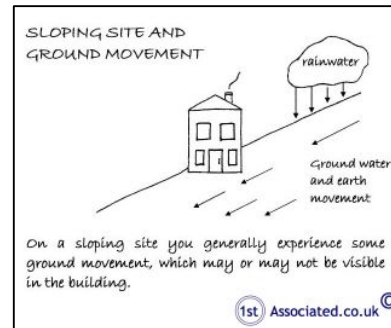
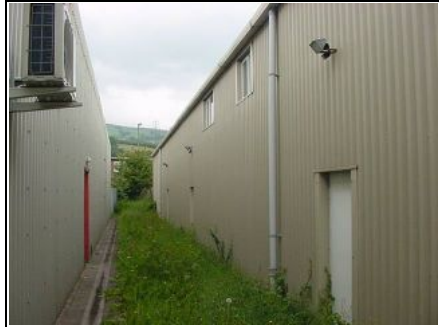
There is a high ground level on the left hand side (sloping site) which is allowing dampness into this area of the property and also into the concrete slab, which is acting like blotting paper. Unfortunately this side also dry lined.

High ground level left hand side

**ACTION REQUIRED:** A way round this would be to put a French drain along the left hand side of the property, although we could not see any drains for them to drain into so you may have to build a soakaway. Please see Appendices.

**ANTICIPATED COST:** In the region of £5,000 to £10,000 depending upon whether you can connect into existing drains or not. Obtain quotations.

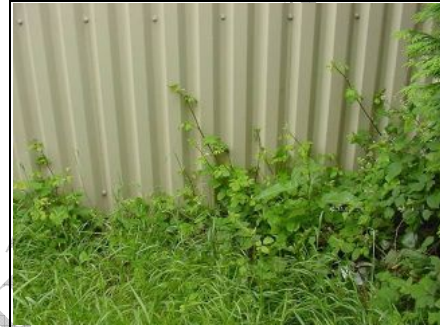
Close up of high ground level

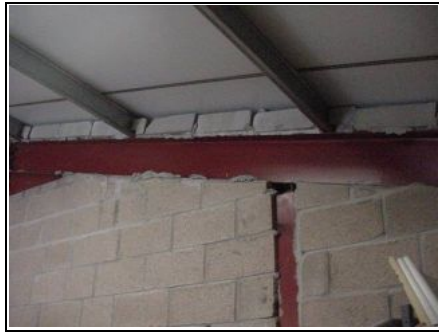
We noted there was no separating fire stop or compartmentisation between the office areas and the storage areas. Depending upon what configuration you will have with the building we believe it is essential to have fire breaks added.

There is what looks to be an existing attempt at a fire barrier / fire wall, which is not sealed properly.

Messy division wall between stock room area and racking area

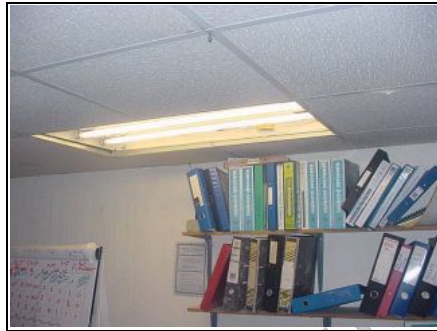
The standard of lighting within the office is not to current standards, where it is normally recommended Category 2 lighting or equivalent, depending upon what is being carried on in the office.

Old style fluorescent lights

**ACTION REQUIRED:** Upgrade to Category 2 lights. There are many factors when upgrading that have to be take into consideration.

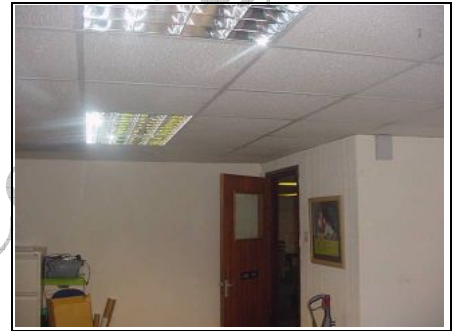
Category 2 light

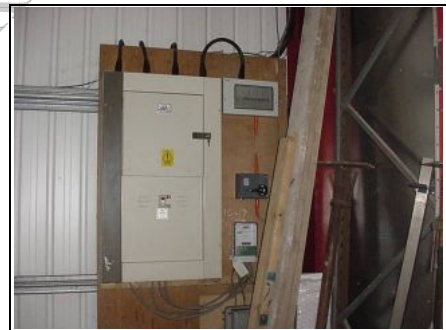
Electric fuseboard front right hand corner near stairway

For the electrics we would recommend an Institute of Electrical Engineers (IEE) test and report is carried out by an NICEIC registered and approved electrical contractor or equivalent.

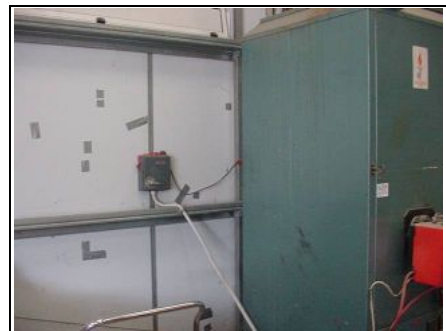
We have mentioned within the Executive Summary about the microbore pipe system being used which we have not found to be that successful (it is not disastrous but nevertheless often we see it changed) and also there looks to be a warm air Parkway system.

Parkway heater which heats the stockroom area

This has not been tested and we would recommend that the system be tested and overhauled before exchange of contracts and that a regular maintenance contract be placed with an approved heating engineer.

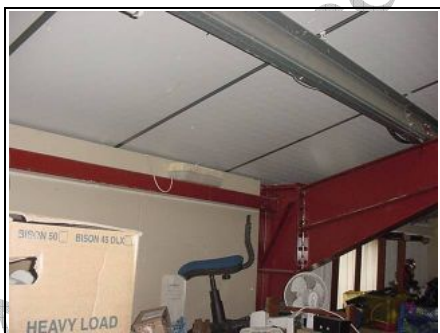
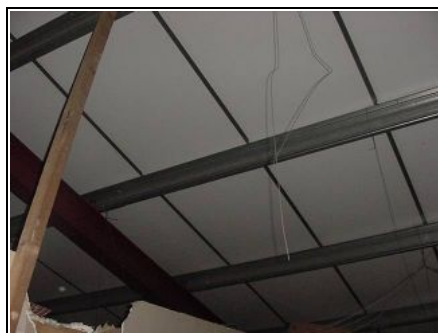
The roof is a shallow pitched metal profile roof. We were unable to view the main roof. Internally there are no visual signs on the under cladding to indicate major problems with the roof. Viewing a roof from the under side is never as good as viewing it from the top, which we would be happy to do but we would need to hire platforms and a tower scaffold.

Under cladding

**ACTION REQUIRED:** Ideally inspect the roof via a lifting platform.

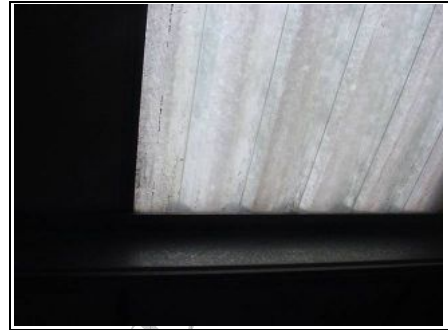
The property has many corrugated roof lights, that look in reasonable condition with no obvious visual signs internally of major water leaks. They do look as if they would benefit from cleaning, but other than this we would say it seems inevitable that the roof windows may sooner or later leak. If this does not occur then particularly in office areas they seem prone to condensation. A true test with regard to a roof light is to inspect them when it next rains and we recommend this is carried out.

Roof window / skylight

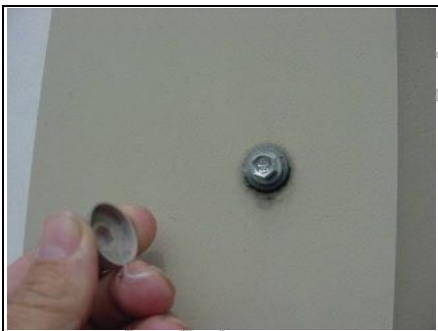
The following shows general damage to the cladding, which is mainly from impact damage caused by vehicles to the right hand side of the property (all directions given as you face the property). However, there are also some areas where the fixing bolts do not seem to have any end caps.

Taking an end cap off

**ACTION REQUIRED:** It is well worth sending someone round with a pack of end caps to fit on to the bolts that fix the cladding in, as these will ultimately rust away.

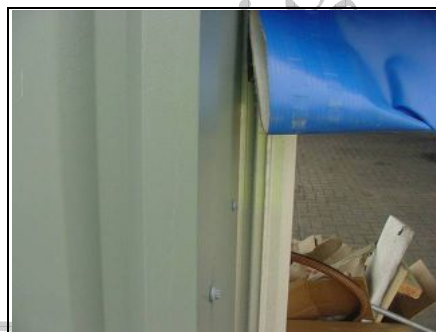
With profile metal cladding we are finding that the proprietary plastic based coating that was put on them is starting to fade over the years. We often find rusting where there has been a cut joint, however unfortunately to replace one panel means that they stand out considerably.

An example of an insulated panel

There is an argument that it is worth replacing this type of original single skin panel with a double skin panel with insulation within it (as per photo example).

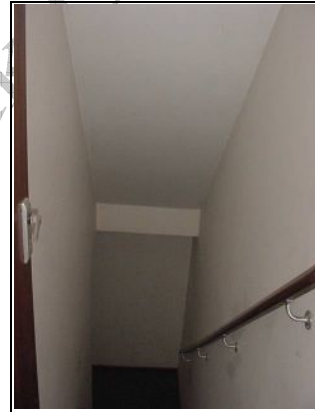
Fire escape plasterboard ceiling

The fire escape area should give a half hour fire resistance; please see our comments with regard to a lack of a fire break as far as we could see, which needs adding.

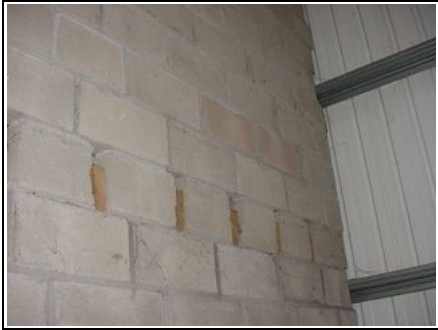
The walls are predominantly in blockwork, which we would say is almost DIY standard in some areas (please see photos below). It could be dry lined to hide it. It is of course impossible to determine the construction without opening up the walls and have therefore taken an educated guess.

DIY quality building of right hand office

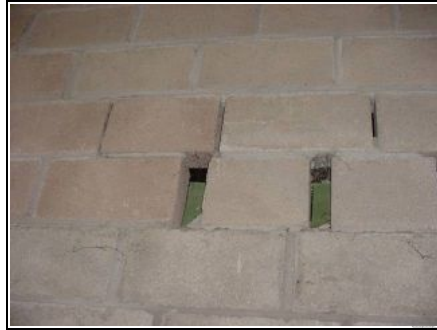
Joist ends not properly supported

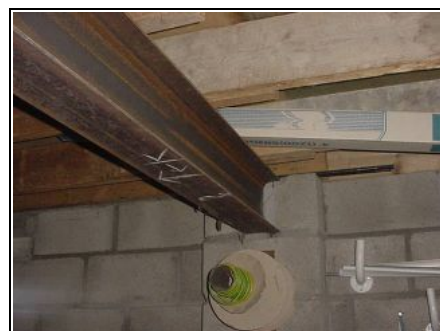
Added RSJ forming support for the first floor timber joists above

**ACTION REQUIRED:** Your legal adviser to check and confirm that Building Regulations Approval has been applied for with regard to internal alterations. We would see 'I' beams have been added that make additional storage space and an RSJ has been added.

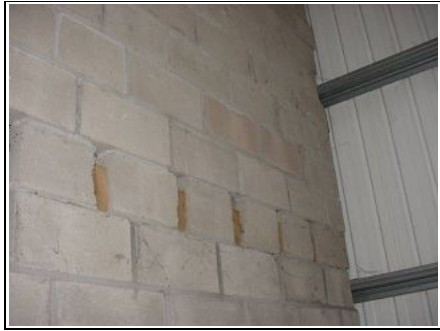
We were advised that the joists did not appear to be sitting on the blockwork fully.

Joists not sitting into blockwork walls properly – DIY Standard

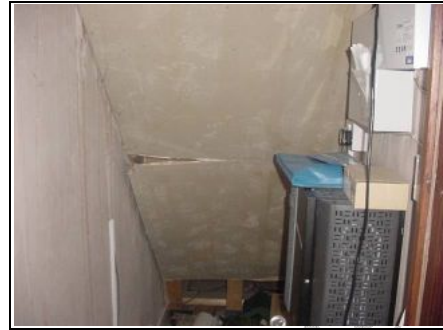
We were unable to examine the underside of the stair timbers due to it being lined, which precluded our inspection, so we cannot comment further upon the stair structure. We can, however, say that the lining gives a resistance to the spread of fire if such circumstances were to occur. The stairs are timber constructed rather than being pre-fabricated.

Lined staircase

**ACTION REQUIRED:** As you can see from the above photo, this would benefit from having the plasterboard re-fixed and there is also a missing section at the bottom so we would check all under side of stairs.

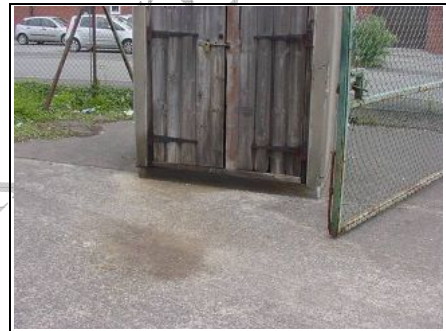
In addition to this you have a petrol/diesel unit which we assume has a tank with it. As far as we are aware these tanks should be tested fairly regularly to ensure they do not leak into the ground and tests should be carried out also in relation to this.

Diesel / petrol shed

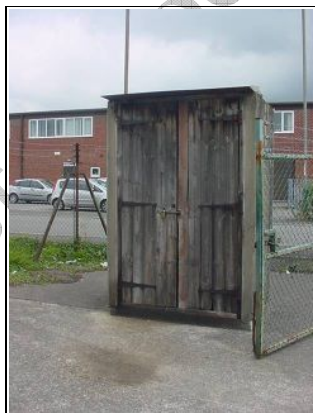
Diesel / petrol shed
